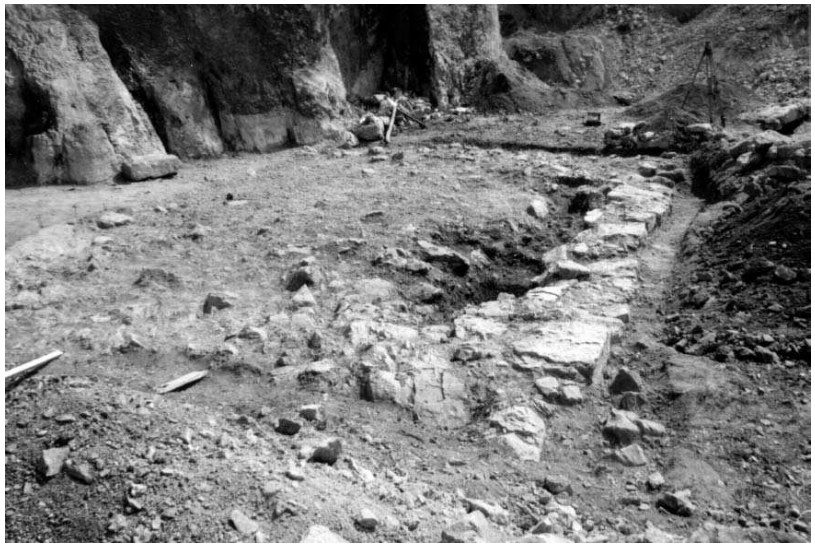
**Слика 2** - Остаци цркве (поглед са ЈЗ)  
**Figure 2** - Remains of the church (from the Southwest)

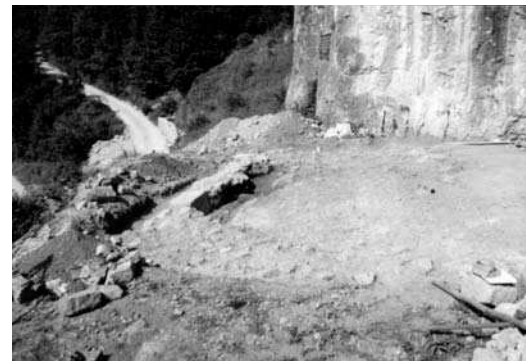
**Слика 3** - Остаци цркве (поглед са истока)  
**Figure 3** - Remains of the church (from the East)

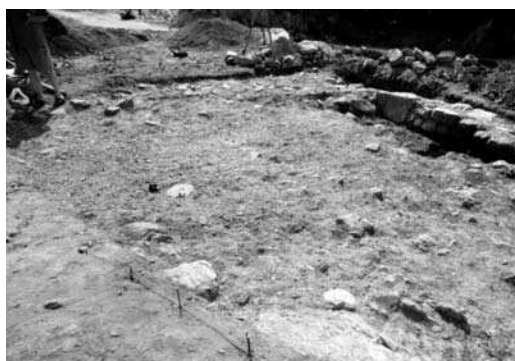
**Слика 4** - Остаци цркве (поглед са севера)  
**Figure 4** - Remains of the church (from the North)

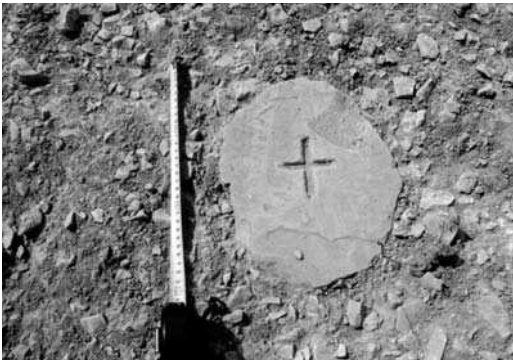
Ни северна траса зида није сачувана. У западном делу претпостављене трасе овог зида је чврста жива стена на којој су уочени трагови горења, а у источном делу, подлога је трошна површина стене. Остатак северног зида цркве представља једино *in situ* пронађен плочасти камен са урезаним крстом. Његов положај на претпостављеној траси северног зида указује да је представљао камен темељац северног зида. Спорадичне покретне археолошке налазе представљали су мањи комади црепа и ексери.

The north wall was also not preserved. In the western part of the assumed wall position we encountered solid bedrock with traces of burning on it, and in the eastern part friable rock surface. Remnants of the north wall of the church are represented only by an *in situ* find of a stone slab with an incised cross. Its position on the assumed axis of the north wall indicates that it used to be a foundation stone of this wall. Occasional small finds were only smaller fragments of roof tiles and iron nails.

**Слика 5** - Камен темељац у северном зиду цркве  
**Figure 5** - Foundation stone in the north wall of the church
